We add this new circuit to ensure no problem occurs due to potential overdriving when working with transmitters which haven't been tested or users are not sure whether they are high-impedance or not. (Most of transmitters are high-impedance.) Another reason to apply the new circuit is to avoid an accidently damage. We did get several reports regarding module failures, which we found out later that most of them happened due to accidently connecting the PPM line to power supply, and burned out the modules.)

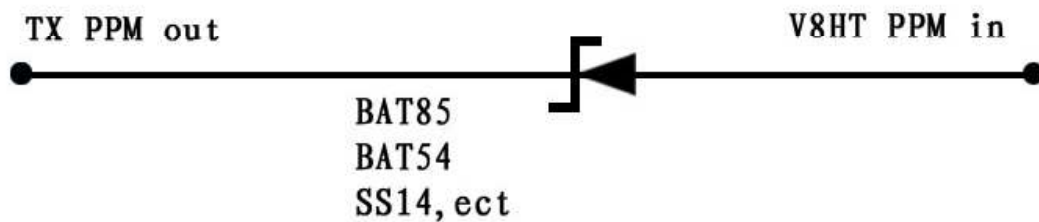
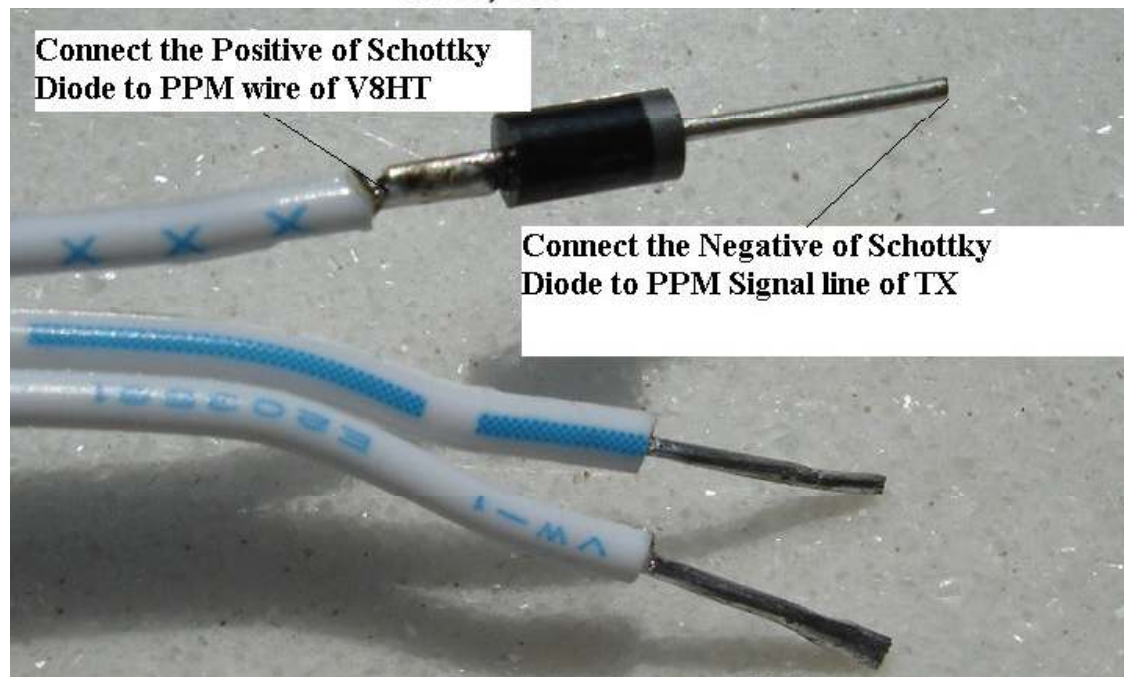
For detailed information, please kindly check the attached drawing and picture for your reference.
